NACA RM E55B09

INFLUENCE OF BORIC OXIDE DEPOSITION ON TURBOJET-
ENGINE OPERATION

By James W. Useller, Richard R. Burley, and
Wallace W. Velie

INFLUENCE OF BORIC OXIDE DEPOSITION ON TURBOJET ENGINE OPERATION

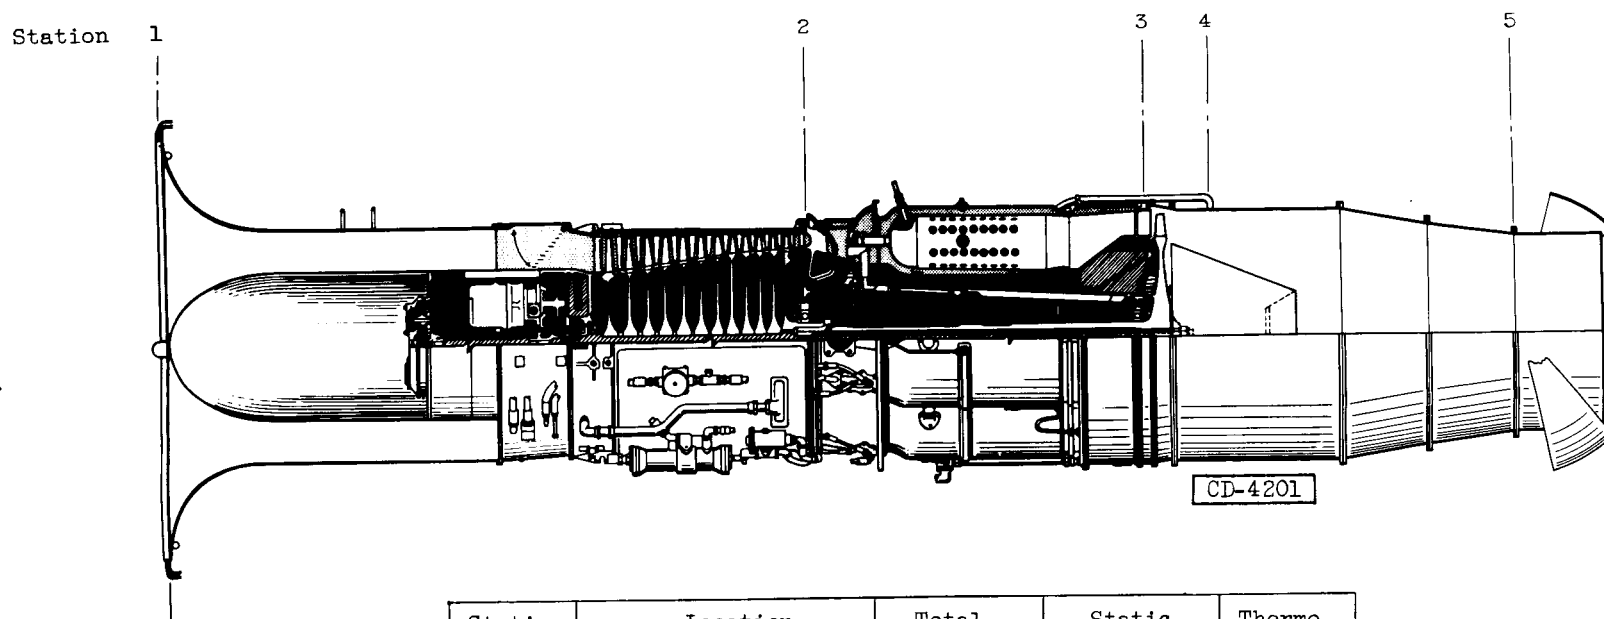
Station	Location	Total-pressure probes	Static-pressure probes	Thermocouples
0	Inlet air measuring station	9	7	4
1	Engine inlet	-	-	20
2	Compressor outlet	10	4	10
3	Turbine inlet	12	-	30
4	Turbine outlet	7	-	20
5	Exhaust-nozzle inlet	12	-	14

Figure 1. - Schematic diagram of turbojet engine showing location of pressure and temperature instrumentation used throughout engine.

Engine and installation. - The turbojet engine used in this investigation was a standard production model with a nominal thrust rating of 5920 pounds at a rotational speed of 7950 rpm and a turbine-discharge gas temperature of 1275° F. A schematic diagram of the engine is shown in figure 1. The following modifications were made to the engine for operation with the trimethyl borate fuel:

Instrumentation. - The number and location of the total- and static-pressure and temperature instrumentation used in this investigation are tabulated in figure 1. Pressure instrumentation used downstream of the combustor outlet was of the air-purging type to exclude collection of boric oxide and subsequent blockage. A sketch of a typical purging-type pressure probe is shown in figure 3.

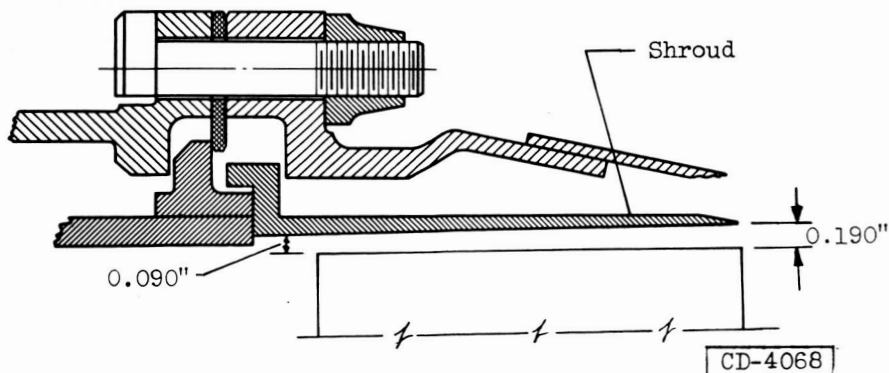
Standard turbine shroud

Modified turbine shroud

(a) Turbine-clearance increase.

Figure 2. - Modifications to standard turbojet-engine components for operation with trimethyl borate fuel.

^aSee fig. 2(a).

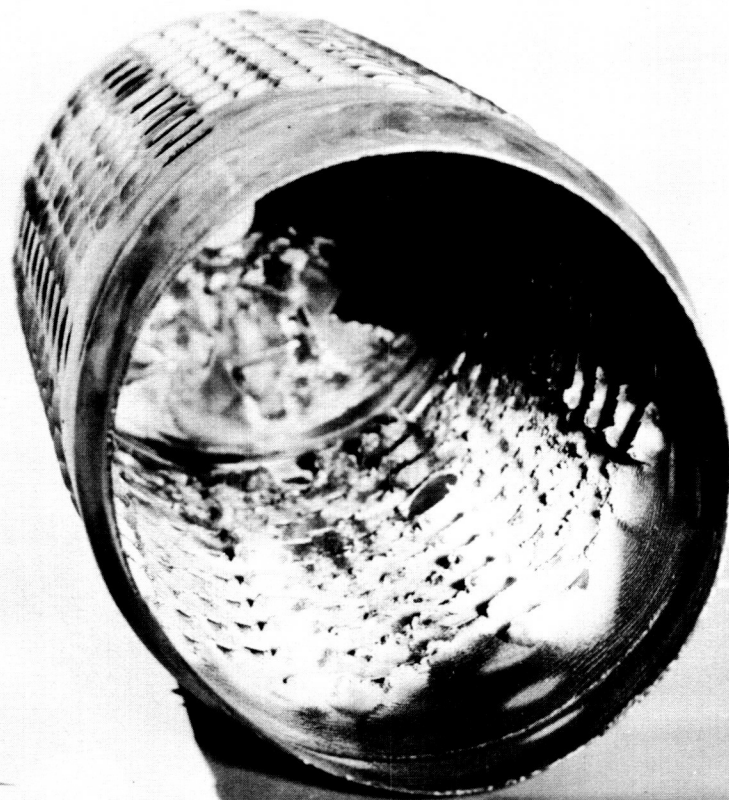
C-36466

Figure 4. - Boric oxide deposits in combustion chamber following engine start and 7 minutes operation. Configuration A.

Boric oxide deposition. - The engine was successfully started with trimethyl borate fuel, and only moderate immediate deposits were formed on the relatively cold metal components during starting. The deposits

in a typical combustion chamber are shown in figure 4 following the engine start and approximately 7 minutes of operation.

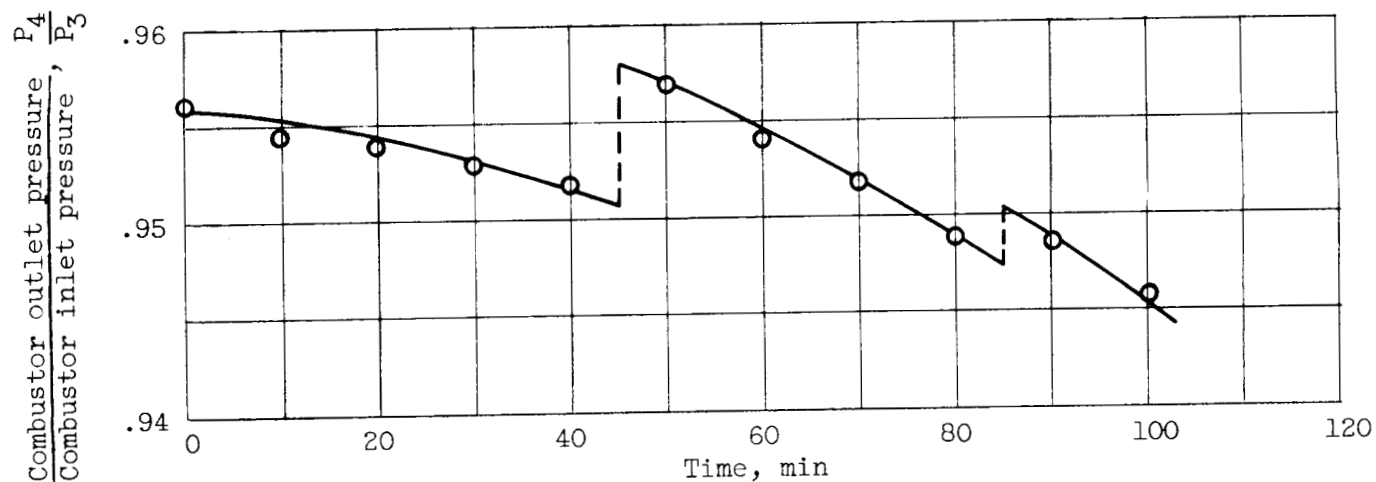
(b) Combustor total-pressure ratio.

Figure 7. - Effect of boric oxide deposition on turbojet-engine temperatures and pressures. Configuration A. Tail-pipe temperature, 1700° R.

The effect of the boric oxide deposits that accumulated in the combustion chambers (shown in photographs of fig. 5) was to increase the total-pressure loss in the combustor. Following 100 minutes of operation with the trimethyl borate fuel, the combustor total-pressure ratio (outlet to inlet) decreased from 95.6 to 94.6 percent (fig. 7(b)).

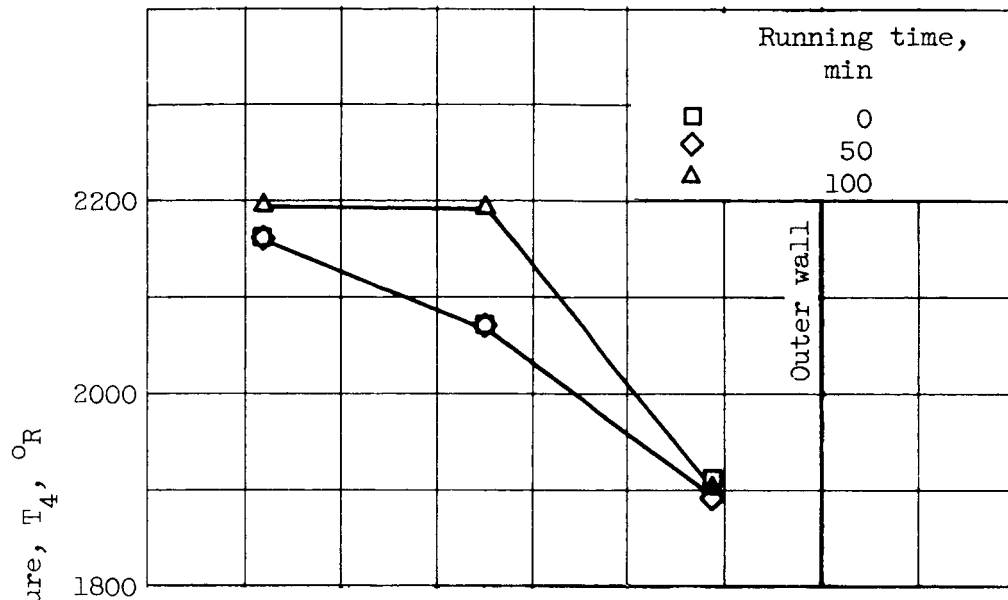
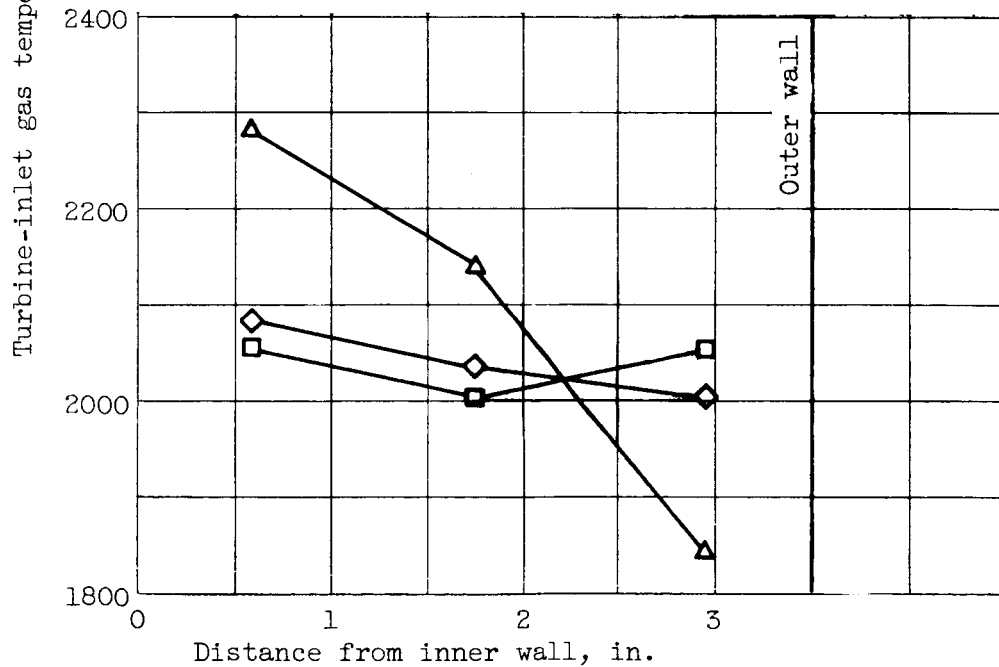
(a) Downstream of combustor 1.

(b) Between combustors 1 and 2.

Figure 8. - Change in turbine-inlet gas-temperature profiles with operation of engine with trimethyl borate fuel.

at the turbine. Figure 8 shows the variation of the turbine-inlet gas-temperature profile at several time intervals during operation with trimethyl borate. Radial profiles are shown for positions at the turbine inlet both behind a combustor and between two combustors. In general, a somewhat steeper temperature gradient from the inner portion of the annulus to the outer wall was experienced with prolonged use of the trimethyl borate. The change in turbine-inlet total-pressure profile is shown in figure 9. Both the circumferential pressure distribution (fig. 9(a)) and the radial pressure profile (fig. 9(b)) were slightly altered because of the accumulated boric oxide deposits in the combustor.

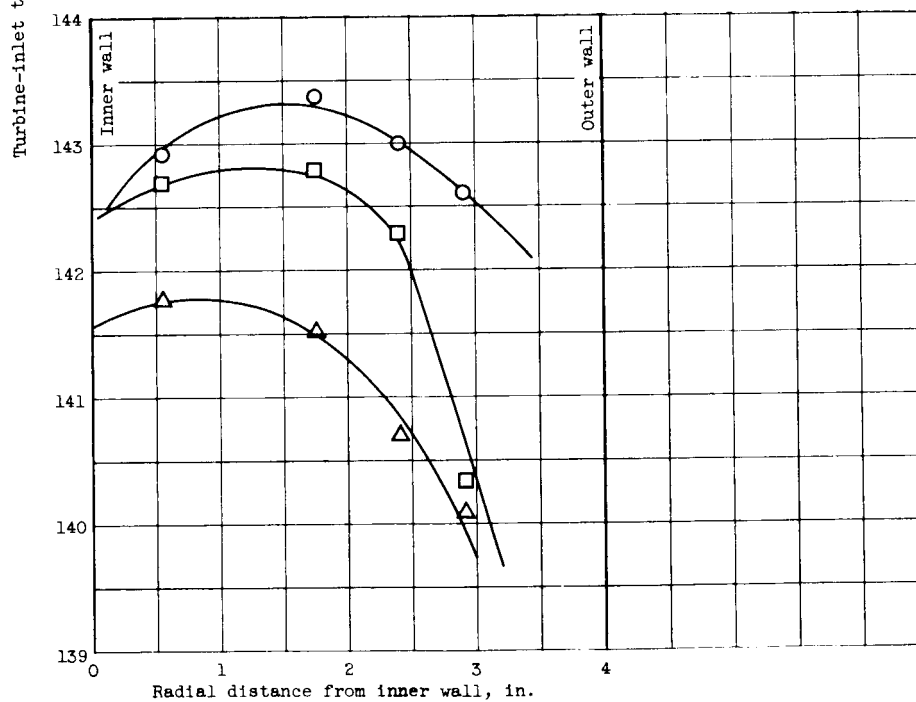
(a) Circumferential pressure distribution.

(b) Radial pressure profile.

Figure 9. - Change in turbine-inlet total-pressure profiles with operation of engine with trimethyl borate fuel.

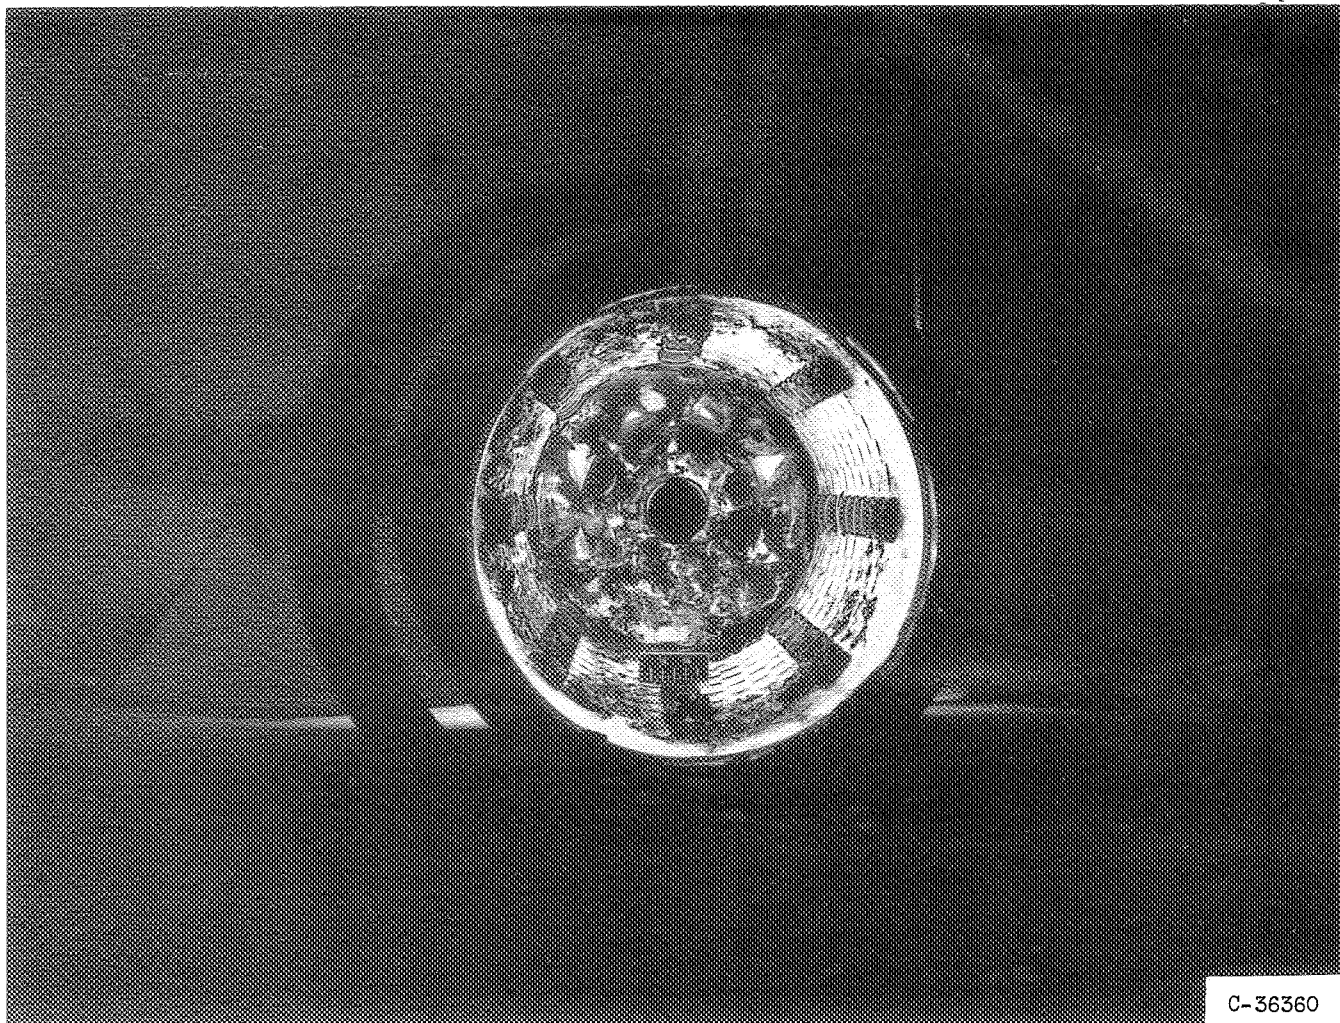
(a) Combustion chamber.

Figure 13. - Boric oxide deposits in engine components following operation with JP-4 fuel for 50 minutes. Previous trimethyl borate operation for 130 minutes. Configuration C.

Subsequent to the operation with trimethyl borate, the engine was operated with hydrocarbon fuel, JP-4. After about 50 minutes of operation with JP-4, the engine speed approached normal operation, as is shown in figure 12, indicating substantial removal of the deposits. Visual inspection showed that the deposits throughout the engine were dissipated by the JP-4 operation. Figure 13(a) shows the deposits in a typical combustor following operation with JP-4 fuel, and figure 13(b) shows the relatively minor deposits remaining in the engine tail pipe.
